# Caelus Energy Alaska Avoids Costly Workover and Saves USD 3 Million

## ACOUSTIC CONFORMANCE XAMINER® (ACX™) TOOL IDENTIFIES LOW-RATE GAS LEAK IN PRODUCTION CASING

ALASKA

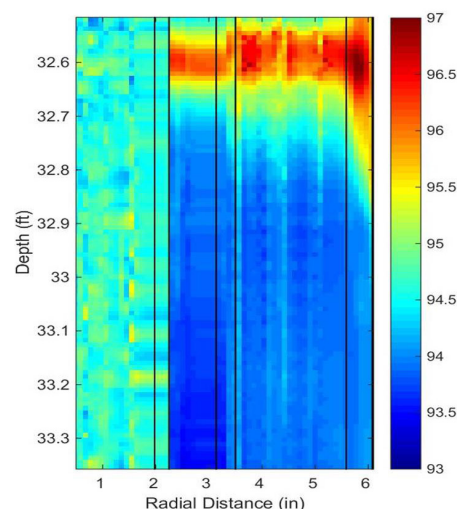
*The flow map is clearly illustrating a leak from the inner annulus (IA) to the outer annulus (OA) only 32 ft from surface. The gas injection was in the IA.*

The gas-only leak was activated by pressurizing the IA while bleeding pressure from the OA. The entire well was logged with the ACX tool, and additional stationary readings were taken at zones of interest. One such zone was near the production casing hanger, which is where the leak was identified by using high-definition waveforms and flow map processing. This same processing was able to rule out several other zones of interest by using radial location, which other ultrasonic technologies cannot do. An additional leak (IA to tubing) was located at a gas lift mandrel and was confirmed to be repaired on a subsequent ACX run after the Halliburton Slickline group changed out the dummy valve.

Since the leak was identified near surface, Caelus Energy Alaska plans to use a sealant repair method and avoid a USD 3 million workover operation.
