Operator Identifies Shallow Surface-Casing Corrosion Without Costly Workover

HALLIBURTON ELECTROMAGNETIC PIPE XAMINER® V (EPX™ V) TOOL DETECTS METAL LOSS NEAR WELLHEAD

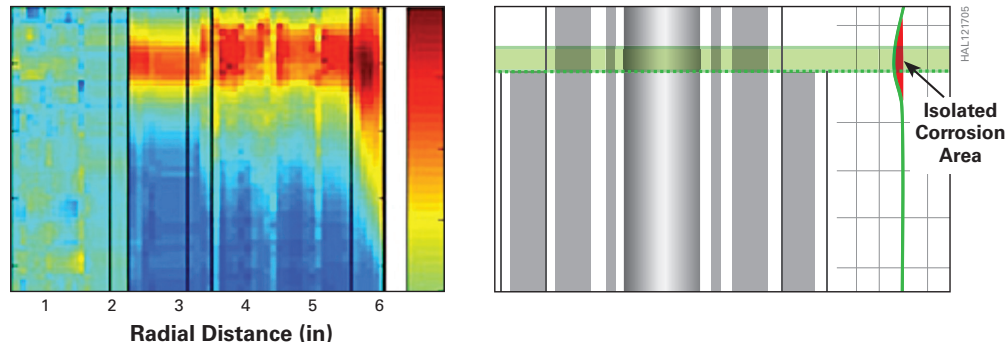
An ACX™ diagnostic service was run on a well with a shallow leak (left). The EPX™ V service indicated metal loss in an area where it should not be. It was further tested, and action was taken to repair this area.

The section of the well in question was logged, and the results indicated a shallow metal loss anomaly within a few feet of the surface-casing hanger. Subsequent surface diagnostics were performed, which indicated a shallow location. The operator cut windows into the conductor casing and positively verified the location and degree of the corrosion.

Since the leak was identified near surface, a rigless external casing repair was performed, saving the cost and avoiding the risk associated with using a rig to cut and pull multiple strings of pipe.
