Hydro-Helical® Gas Separator Testing and Qualification Process

Slurry Loop Test

Limited Erosive Wear

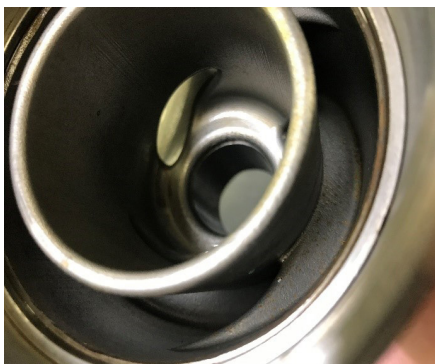
Separation Chamber » View from the bottom, inside the crossover

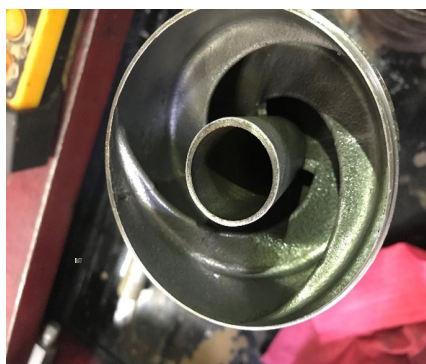
Separation Chamber » View from the top of the helix, looking down

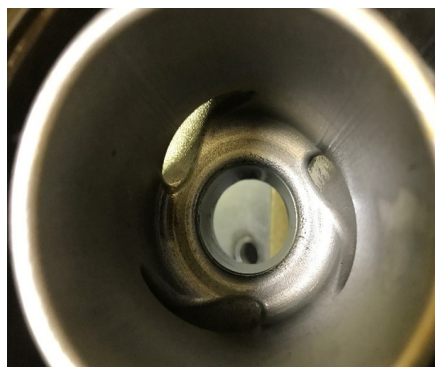
Separation Chamber » View from the bottom, inside the crossover gas exit ports

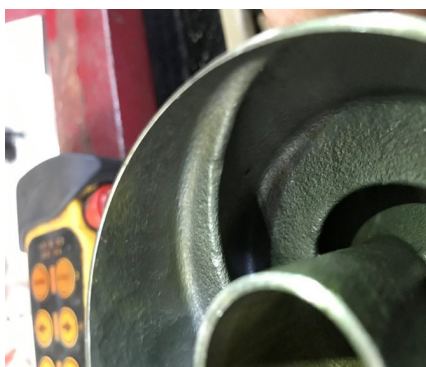
Separation Chamber » Close-up view from the top of the helix, looking down

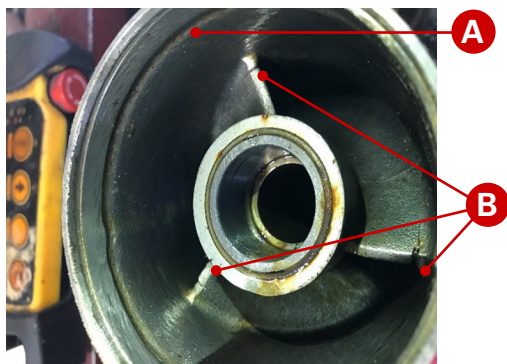
Separation Chamber » View of the bottom of helix

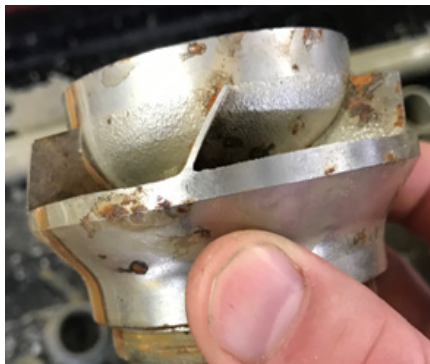
Separation Chamber » View of the flow diverter (top impeller)

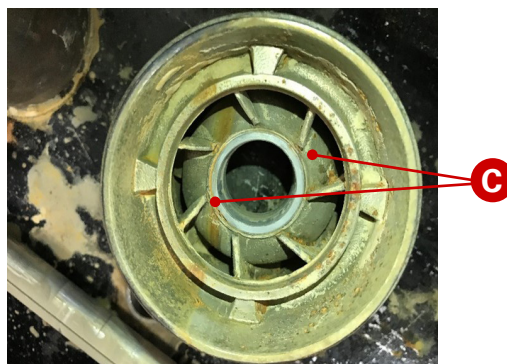
Separation Chamber » View of the upper-most diffuser, looking down

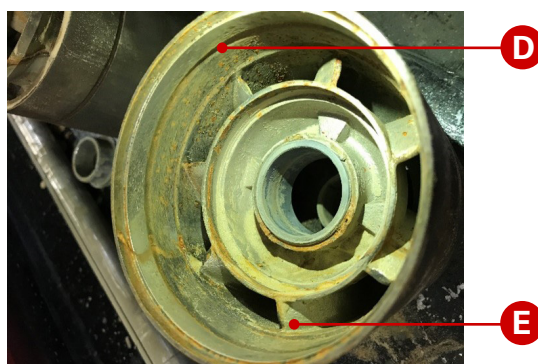
Separation Chamber » View from the bottom of the upper diffuser

- A. Approximately .03 erosion ring in the liner of the helix where the flow-diverting impeller operates (wall thickness is .187) common in all the fluid moving stages
- B. Slight wear of the leading edge of the helix vanes
- C. Slight wear on the trailing edge of the vanes
- D. Approximately .03 erosion ring in the liner where the lower impeller operates (wall thickness is .187), which is common in all the fluid moving stages
- E. Slight wear of the leading edge of the helix vanes
