How to Solve Blow Molding Problems

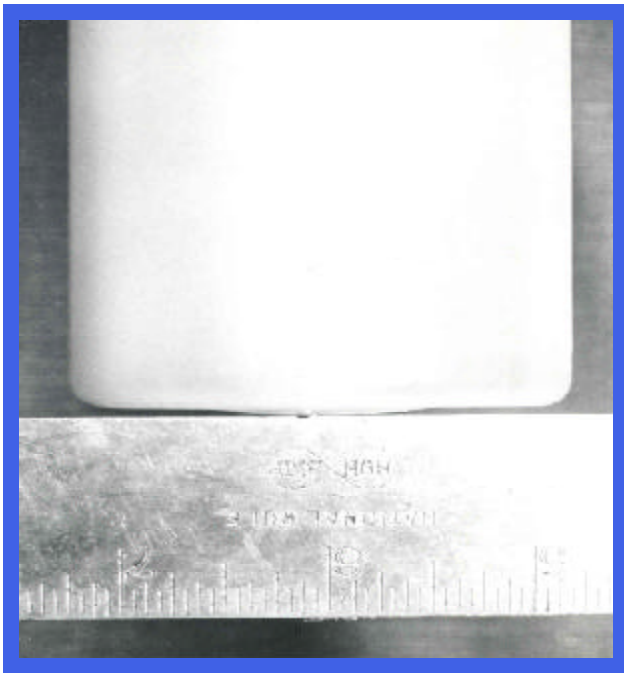
Rocker Bottoms

These two defects in blow molded objects are the result of warpage. The cause is, in general, the same that results in warping in parts made from other plastics molding processes: inadequate or uneven cooling of the part prior to its removal from the mold. Possible causes and solutions follow:

1. Insufficient cooling water to the mold
 - Increase flow and determine if this eliminates warpage.
2. Stock temperature too high
 - Try dropping the temperature by small amounts to see if this will solve the problem without resulting in new concerns such as cold spots in the container wall.
3. Blocked cooling channels
 - Check the cool out throughput. If it is significantly less than when the mold was new, a thorough cleaning of the channels is needed.

4. Cycles too short
 - If 1, 2 and 3 have not solved the problem, determine whether the cycle times are unrealistically short to keep productivity high. If cycles are reasonable for adequate cooling, proceed to the next group of possibilities.
5. Poorly designed cooling channels
 - The mold may have to be reworked to increase cooling capability or the uniformity of cooling.
6. Poorly designed part
 - Too great a variation in the distribution of material in the part, yielding unnecessarily thick and thin sections, result in warpage unless the part is thoroughly cooled. This may demand an uneconomically long cycle. Parison programming or a redesign of the part itself may be necessary.

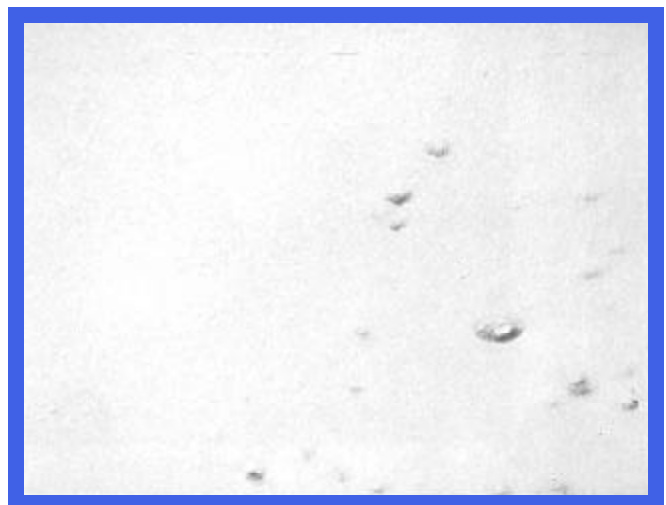
Bubbles are generally symmetrical areas on the wall of the object, usually clearer than the surrounding area. Moisture in the melt is the usual cause. Following are some methods for eliminating this problem.

1. Moisture condenses on the surface of cold resin that is exposed to the warmth of the blow molding shop.
 - Allow the resin to warm up and the moisture to evaporate before it enters the extruder.

- Let the resin warm up by keeping a few unopened gaylords in a warm room.
 - Discharge direct draws from hopper cars or trucks into indoor surge bins where the resin can warm up and moisture evaporate before moving to the extruder hopper.

- Increase barrel temperature in the feed and/or transition sections of the screw to remove any further moisture.
2. Overdone water cooling on the throat of the extruder, resulting in water condensing in the barrel

- Decrease water cooling on the throat.
3. Non-moisture causes of bubbles
 - Check material leaking from mismatched head sections and rectify, as this also can be a source of degraded resin.

- Make sure back pressure is sufficient. If not, adjust the back pressure gauge on reciprocating blow molding machines and change to a finer mesh screen pack on continuous extruders.

- Check for screw wear. If severe, replace the screw.

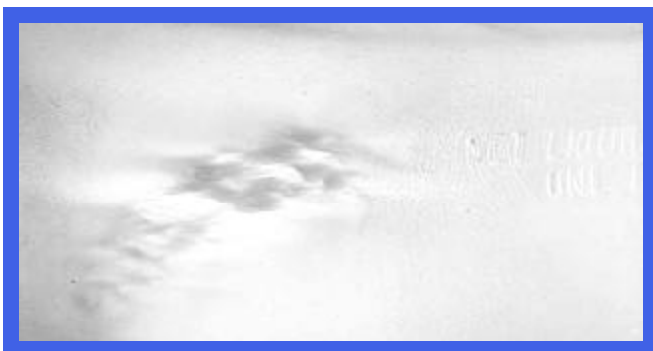
Cold Spots show up as non-homogeneous areas in the wall of the blown object. This can also be caused by insufficient back pressure or non-uniformity in the melt. Solutions are the same as for bubbles.

Cold Spots also can result from a resin mixture in which some material has a lower melt index. The resin does not melt completely and extrusion conditions are inadequate for the lower melt index material, resulting in defects on the blow molded part.

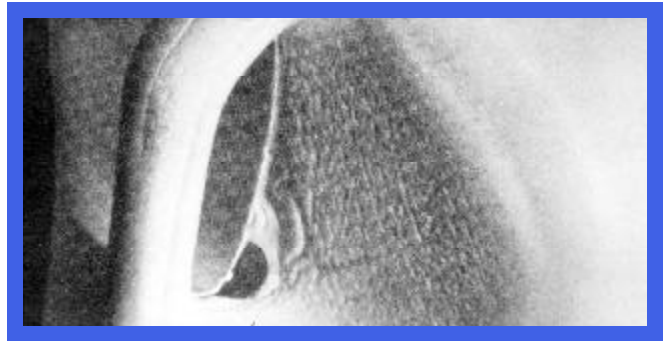
Cutting at the Pinch-Off

Cutting can be the problem if a hole or slit is found in a weld in a part with flash attached.

1. Stock temperature too low
 - If the weld and pinch-off both seem satisfactory but there is a hole or slit along the weld, the parison may be tearing as the mold closes because of cold stock. Raise the stock temperature in 5-10°F increments until the cutting ceases.
2. Molds close too fast and slam or snap shut — Ease off the closing cycle to make better welds and preserve the molds.

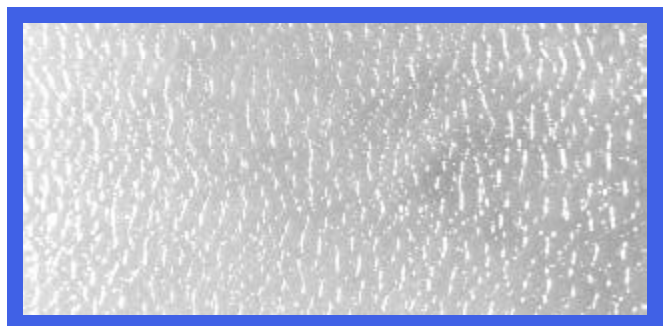
Rough Parison

7. Rough parison
 - A rough parison usually results from operating the blow molding process at a shear rate that produces flow instability in the melt. Melt instability is more likely to occur when continuous extruders are run near or at the highest rates of which they are capable. With reciprocating or accumulator types of blow molding machines, melt instability is more likely to occur when the extruders are run near or at the slowest rates of which they are capable.

- decrease the extrusion rate until rough parisons no longer occur.
- change extrusion tooling to a set with longer land length.

- decrease extrusion rates (increase drop time)—but this is generally unsatisfactory because of the decrease in productivity.
- increase extrusion rates, and thus move up out of the region of melt instability (decrease drop time)—a more satisfactory solution.
- increase stock temperature or change to a higher melt index resin, if extrusion rates cannot be increased.
- change extrusion tooling to a set with longer land length.

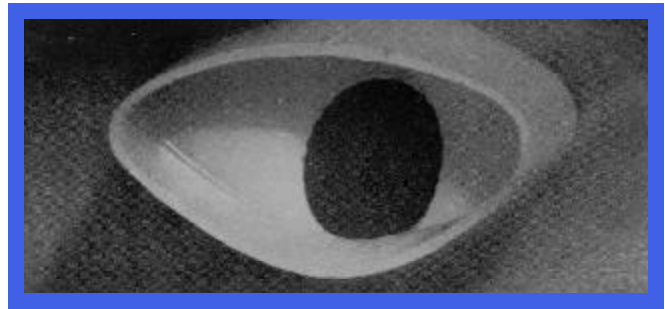
Webbing in the Handle

1. Poor tooling design
 - Too short a land length between bushing and mandrel results in poor control of flow through the die gap, leading to areas of high and low flow. The result is parison folding.

2. Die misalignment
 - Bushing and mandrel misalignment also produces differential flow rates in different areas, resulting in folding.
3. High stock temperature

- Very high stock temperatures result in parisons with low melt strengths. Such parisons collapse and fold before they can be blown.
4. Resin swell
 - If the resin used has too high a weight swell, an attempt is often made to reduce part weight by decreasing the die gap. However, decreasing the die gap can yield a very thin parison that quickly collapses and folds. A resin with low diameter swell characteristics may cause lower handle webbing and in severe cases, even blow-outs. In this case, the parison is caught in two places by the inner handle pinch-off. When blown, these areas meet to form a heavy area known as a web.

5. Low parison diameter swell
 - High stock temperature and/or low shot pressure will yield a parison with low diameter swell, resulting in lower handle webbing.

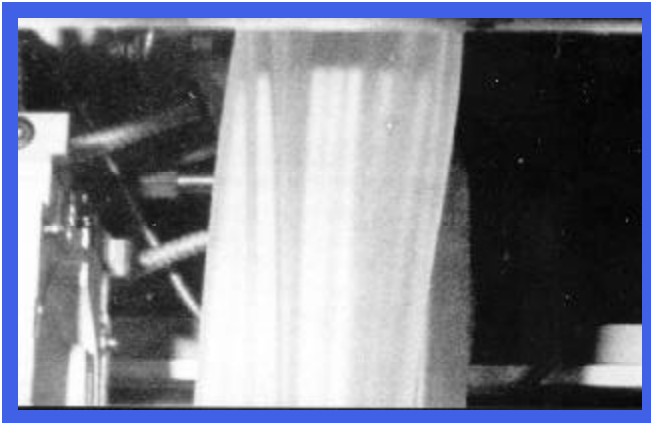
Curtaining of the Parison

Curtaining or folding of the parison as it extrudes from the die can cause webbing in bottle necks and handles. If the effect is severe, the handle can be partially or completely blocked. Folds in the neck can lead to problems in filling operations or in reaming and facing, thus affecting the fit of the cap.

6. Mold position
 - Improperly positioned molds that are shifted away from the parison will result in containers with lower handle webbing.
7. Hooking parison
 - If the parison hooks away from the handle, webbing problems similar to those described above will also occur.
8. Ovalized tooling
 - If oval tooling is improperly designed, the problems described above can occur.
9. Pre-blow air pressure
 - If pre-blow air pressure is low or is lacking entirely, curtaining and webbing can occur. Increase the pre-blow air pressure to minimize this effect.

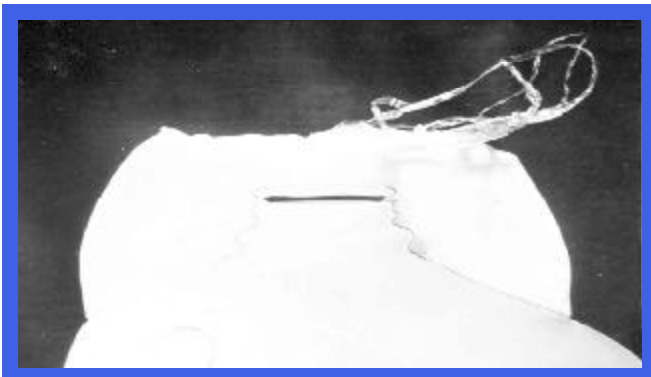
Melt Stringing

Parison stringing also occurs when the parison is extruded, but is caused by too high a melt temperature. Thin, feathery strings of melt are attached to the top and bottom flash of the blown part. If stringing is severe, bottles remain attached to each other and the lower bottle's weight may thin out the next parison to the point that blow-outs occur, particularly in a handled bottle. Causes follow:

1. Stock temperature too high
 - Gradually lower the temperature. However, if cold spots occur when the temperature is lowered, it may be necessary to change to a different resin.
2. Fill pressure on reciprocating screw-type machines too high
 - Excessive "weeping" of polymer from the die occurs, causing the parison to string during part removal.

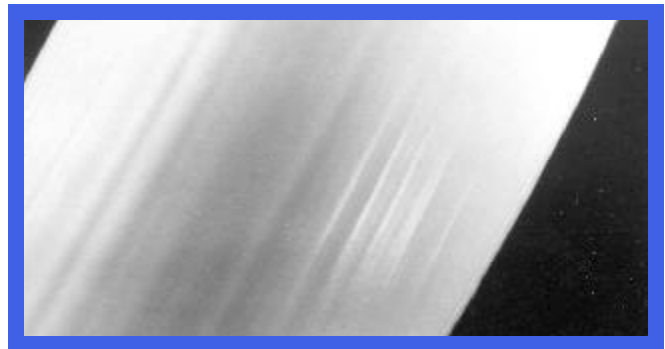
Die Lines or “Streaking”

Streaking is usually the result of foreign matter or degraded resin lodged between the die and mandrel. See the section on degraded resin under “Foreign Matter in the Melt,” on the preceding page.
