HalKleen™ G Scale Removal Service – Case History 1

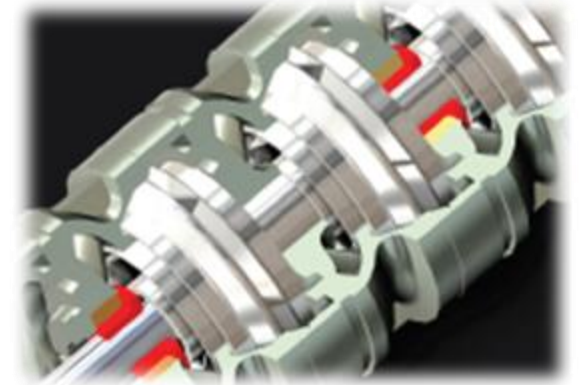
- Well A - Offshore oil producer, casedhole and perforated completion.
- Low pressure, heavy oil (11°API), producing through ESP
- Calcium sulfate scale inside the ESP pump (increased operating temperatures of the pump)
- XRD analysis revealed >90% CaSO₄
- Typically, ESP's had been damaged leading to well maintenance and intervention costs, lost time, and deferred oil production for this field.

- ESP motor temperature decreased by 13°C.
- Well is currently producing at expected rates

- 25-bbl pill of HalKleen™ G scale dissolver
- Pumped through the production tubing and allowed to soak for 1 hour on the ESP pump
