Boots & Coots Regains Control of Well After Blowout Occurs During Workover Operation

TEAM CONTAINS WELL IN EMERGENCY SITUATION WITHOUT INCURRING ANY INJURIES

CASE STUDY

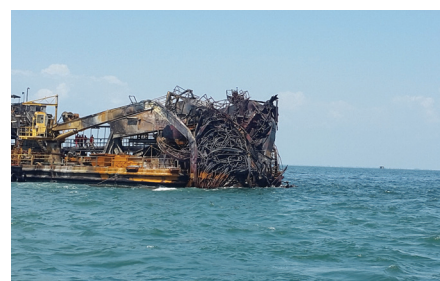
During the workover operation from a single well platform, a blowout occurred with devastating consequences to the barge rig equipment and well platform. Consequently, due to the conflagration, the derrick collapsed and scattered debris across the platform.

Fire from the blowout causes the derrick to collapse on the barge.

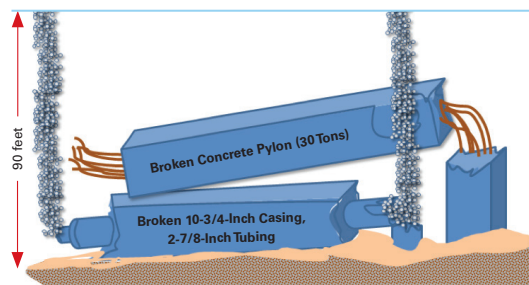
The underwater survey showed that the well platform, casing, and tubing strings had been bent and collapsed on the well (as illustrated below), increasing the challenges. Additional debris littered the lake bed surrounding the wellhead, which restricted access and the ability to clearly monitor the wellhead. Furthermore, the turbulence from the gas flow through the debris disturbed silt and clay on the lake bed and clouded the visibility around the well.

This illustration shows collapsed casing and tubing strings over the well.

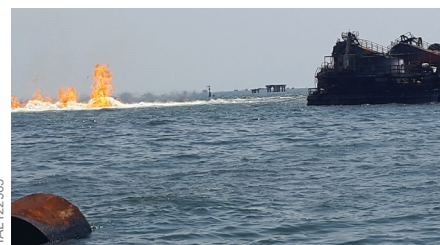
The Boots & Coots well control team was mobilized to the location to assess the situation and assist the operator on the response plan and operation. The team initially inspected and assessed the conditions of the barge and well. Gas was flowing into the lake bed and then to the water surface where it had caught fire.

Surfacing gas spontaneously catches fire on the lake surface.

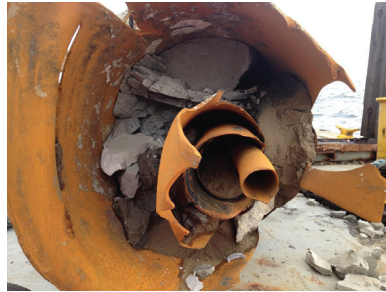
HAL122573

Boots & Coots specialists oversaw the capping operation and safely conducted a successful landing to secure the well.

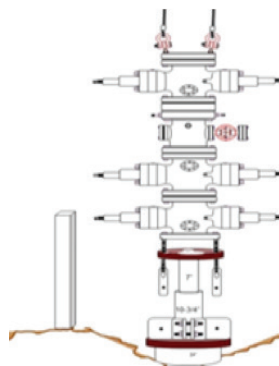
HAL122567

A modified surface capping stack is lowered onto the well to successfully cap and contain the well.

The well source control procedure required installing a capping stack on the well, so a decision was made to dredge sufficient depths of the lake bed in order to access competent production casing for the capping operation. A total of 18 feet (5.5 meters) of the lake bed was dredged with special turbine equipment to uncover a sufficient length of competent production casing.

Boots & Coots designed a modified surface capping stack, based on the available 11-inch x 10-meter (33-foot) blowout preventer's (BOP's) surface equipment. The compromised section of the casing was cut to expose a sufficient length of competent casing for the subsea capping operation. Boots & Coots specialists oversaw the capping operation and safely conducted a successful landing to secure the well.
