# Boots & Coots Drills Relief Well for Shallow Target to Kill Catastrophic Blowout

## MULTIDISCIPLINARY RESPONSE RESOLVES CRISIS IN FIRST ATTEMPT

INDONESIA

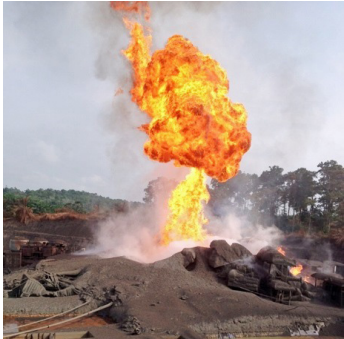
HAL62386

Figure 1. The catastrophic blowout of the shallow gas well created a crater that swallowed up the rig and caused the drillstring to drop down the open hole.

The operator’s wellbore was exposed to shallow, weak geological formations. While drilling the top section ahead of setting the surface casing, the operator detected a kick. With the well drilled to a depth of 2,160 feet (658 meters), and the last casing seat set at 40 feet (12 meters), the flow was diverted. After unsuccessful attempts to contain the well from the surface by pumping fluid, the diverter system eroded and fire quickly engulfed the site. The rig collapsed into the crater and the drillstring dropped into the open hole. The operator contacted Boots & Coots to kill the blowout. Apart from containing the blowout, a major challenge was determining the precise location and trajectory of the target well, as survey data was very limited.

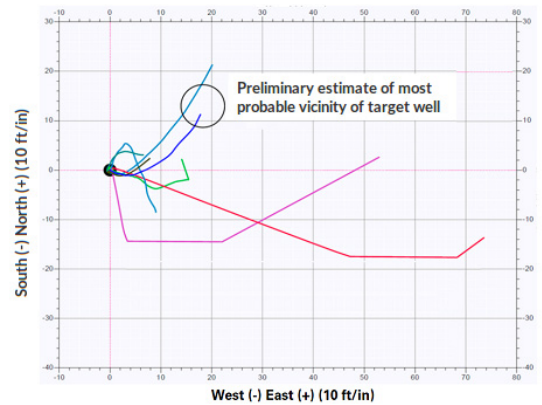
Figure 2. Because there was no survey data on the target well, data on offset wells in the area were used for trend analysis.

Survey data of the site was limited to only four sets of inclination data. And because there were no details about the target well’s trajectory, the ellipse of uncertainty was quite significant. To locate the target well, the team turned to survey and drilling data on eight offset wells in the area to ascertain the general trend and trajectory.

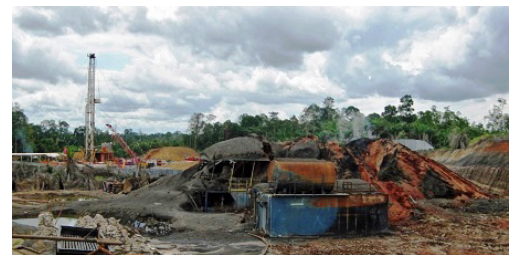
Figure 3. The relief well can be seen in the left background, 500 feet (152 meters) behind the destroyed target well.

It was a complex undertaking to position and design the relief well to intersect possible sidetracks of the target. It was set 500 feet (152 meters) from the surface location of the target well, and drilling began with a 6-1/8-inch pilot hole to a depth of 170 feet (52 meters), then opened to 26-1/2 inches. After a 20-inch casing was set, drilling resumed with a 17-1/2-inch bit and deviated at 300 feet (91 meters) to reach an inclination angle of 30 degrees. A 13-3/8-inch casing was then set at a depth of 1,360 feet (415 meters).
