WWTP maintains phosphate discharge compliance using Hach BioTectors

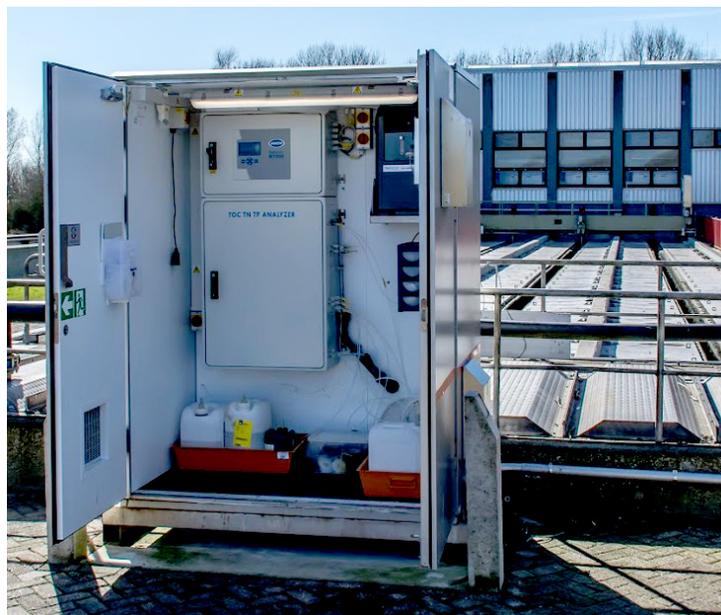
Biotector unit at the Oijen WWTP

The customer needed to know more about the composition of their influent and effluent wastewater. This resulted into the installation of a BioTector B7000 for reliable monitoring of their effluent streams for C, N, and P discharge.

The second phase involved gaining insight on C/N/P ratios hitting their wastewater influent, so a second BioTector B7000 (TOC/TN/TP) analyzer was purchased. This unit reliably monitors the influent in real-time, and allows a rapid response to sudden composition changes, eliminating the significant costs of restoring the process after such a disturbance. Real-time data drives insights into whether there are problems with the process, or problems caused by external discharges.
