Halliburton Electromechanical Cutter Helps Operator in the North Sea Save Days of Nonproductive Time

NEW PIPE-CUTTING SOLUTION HELPS ACHIEVE REQUIRED P&A, ELIMINATING THE NEED FOR FISHING

UNITED KINGDOM

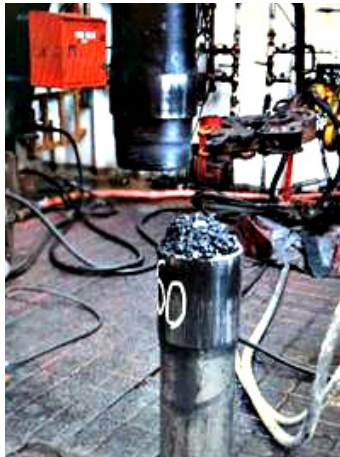
HALL125518

A slickline crew at the wellsite deployed multiple drifting/gauging and bailing runs to prepare the well for the electromechanical cutter deployment. E-line was used to deploy the electromechanical cutter successfully to target depth. A Halliburton specialist demonstrated to the on-site customer rep the different phases of cutting through the debris and then through the tubing. A final positive indication of pipe cut was available within minutes using the electromechanical cutter's surface-readout control panel. A precisely located, machine shop-like-quality tubing cut was successfully retrieved to surface. With the electromechanical cutter deployment, the customer potentially saved days of attempts to clear the obstruction and removed the need for any fishing operations.
