Eddy County, New Mexico

# DuraHard® 7 coating provides enhanced protection against erosion and wear from frac sand

Operator extends run time with specially coated pump

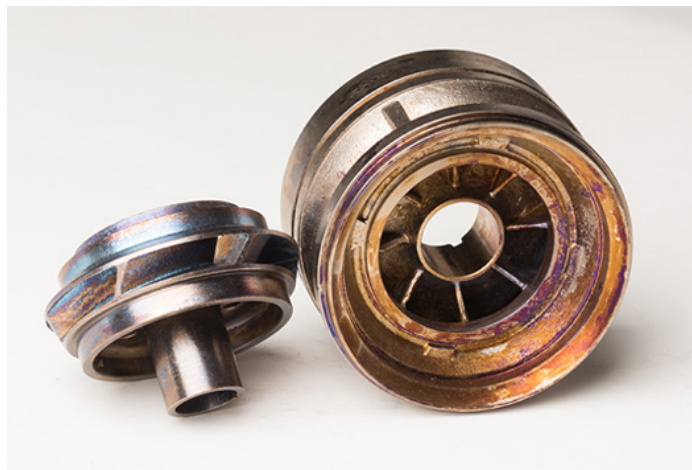
DuraHard® 7 high-phosphorous nickel coating provides non-molecular surface hardness to impeller and diffuser surface pump stages.

Summit ESP® recommended DuraHard® 7 enhanced abrasion and corrosion-resistant coating be applied on the impeller and diffuser pump stages of the ESP system to extend run times. DuraHard coatings protect against friction, abrasive, and corrosive conditions, providing longer pump run life. This enhanced level of protection uses a high-phosphorous, nickel coating that provides additional, non-molecular surface hardness to stage materials.
