Hydro-Helical® Gas Separator Testing and Qualification Process

Slurry Loop Test

Limited Erosive Wear

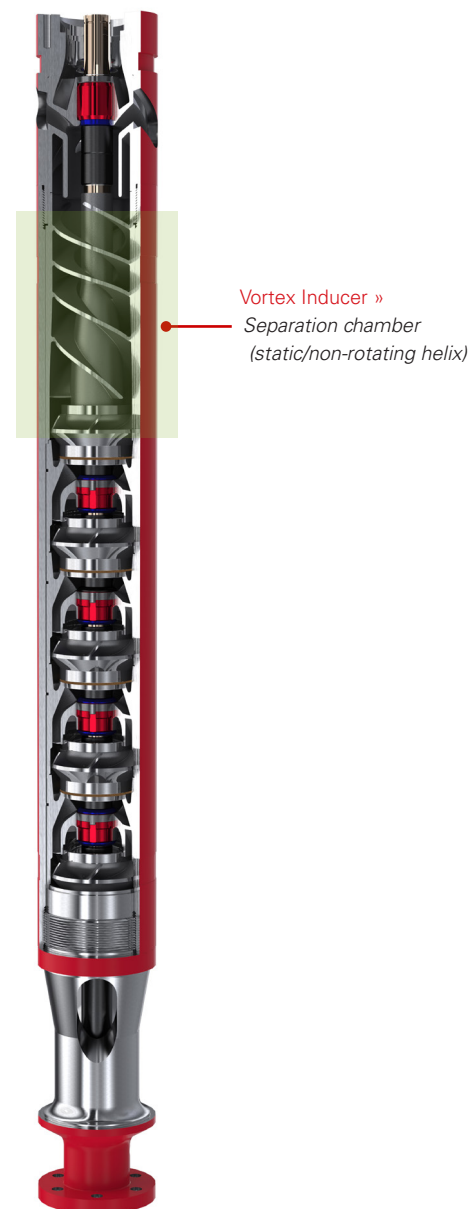
Separation Chamber » View from the bottom, inside the crossover

Test results showed a significant reduction of erosion within the separation chamber area. The non-rotating design of the Hydro-Helical separation system all but eliminated erosion damage. The transition from the separation chamber to the crossover showed little to no erosive wear due to the smooth exchange of the fluid's flow path. The real improvement in erosion mitigation came from the "stationary" vortex.

In the stationary vortex, however, the relative velocity was lower, and turbulence was reduced because of gentle flow passages, reducing erosive wear and significantly improving the tool's reliability.

- A. Approximately .03 erosion ring in the liner of the helix where the flow-diverting impeller operates (wall thickness is .187) common in all the fluid moving stages
- B. Slight wear of the leading edge of the helix vanes
- C. Slight wear on the trailing edge of the vanes
- D. Approximately .03 erosion ring in the liner where the lower impeller operates (wall thickness is .187), which is common in all the fluid moving stages
- E. Slight wear of the leading edge of the helix vanes
