North Sea, Norway

Halliburton collaborates with neptune energy to free stuck drillpipe in subsea wellhead/BOP

Innovative ClearCut[™] downhole cutting technology makes successful cuts in pipe recovery operation, saving rig from excessive downtime

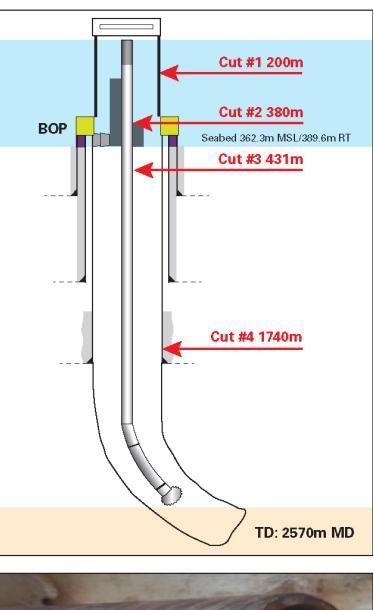
ClearCut[™] powered mechanical cutters to provide a high level of cutting accuracy, and to eliminate the need for radio silence, explosives, and chemicals

ClearCut powered mechanical cutters perform precisely located, machine-shop-quality radial pipe cuts, regardless of depth and pipe compression – thus giving the important advantages of having a completely clean pipe end. The tool's high accuracy ensures that only the pipe is cut, with no damage to the outer casing or control lines.
