CrystalSeal[®] Conformance Service – Case History 1

- US – Permian - CO₂ EOR project
- Interwell communication / out-of-zone injection, due to highly eroded channels

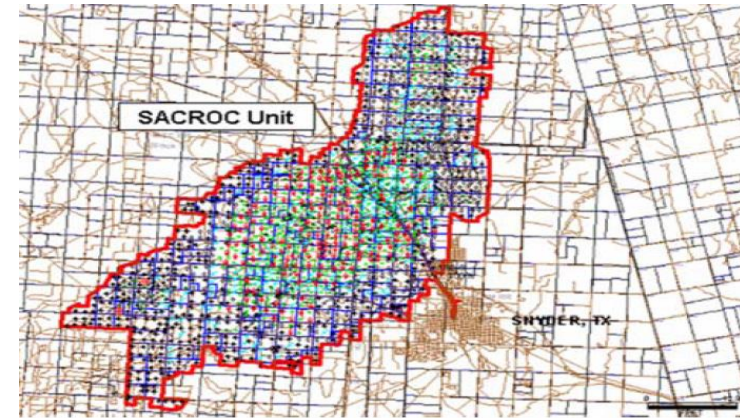
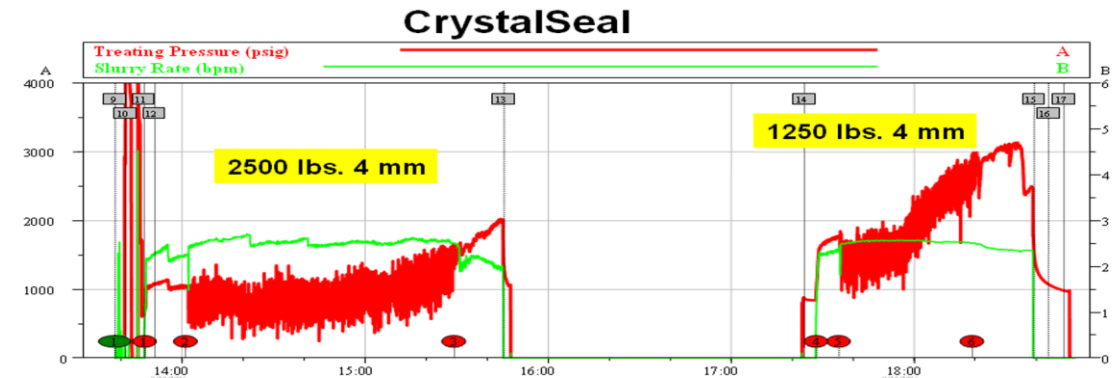
- CrystalSeal[®] bullheaded into the WAG injection well
- Two stages were deployed until a significant pressure response was achieved.

- Improved injectivity profile
