H₂Zero[®] Conformance Service – Case History 1

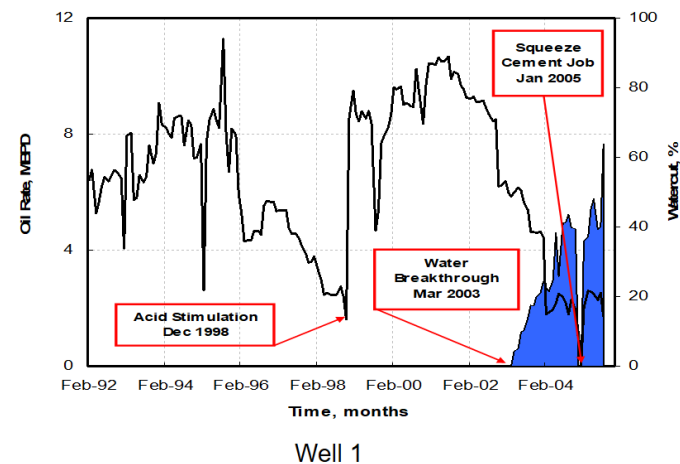
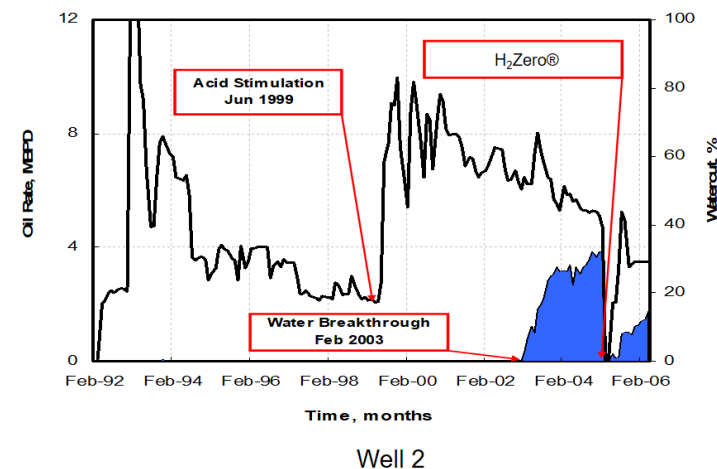
- Conventional cement vs. H₂Zero[®] Conformance service (deep reservoir penetration)

- Longer treatment life achieved with H₂Zero[®] Conformance service
