CASE STUDY: BG PLATINUM® FUEL SYSTEM SERVICE

SERVICE	BG Platinum [®] Fuel System Service	
PRODUCTS	BG Platinum [®] Air Intake, Valve & Combustion Chamber Cleaner, PN 261 BG Platinum [®] 44K [®] , PN 208	AG PLATINUM WAINE BG PLATINUM HILLE COST CALLENCE
EQUIPMENT	BG Platinum [®] Fuel Service Supply Tool, PN E101-1249 BG AE03 Intake Adaptor, PN E101-1541 3/8" Jumper Hose	
	VEHICLE: 2018 VW Atlas, 3.6L 15,953 miles (25,674 km)	11 - 2044

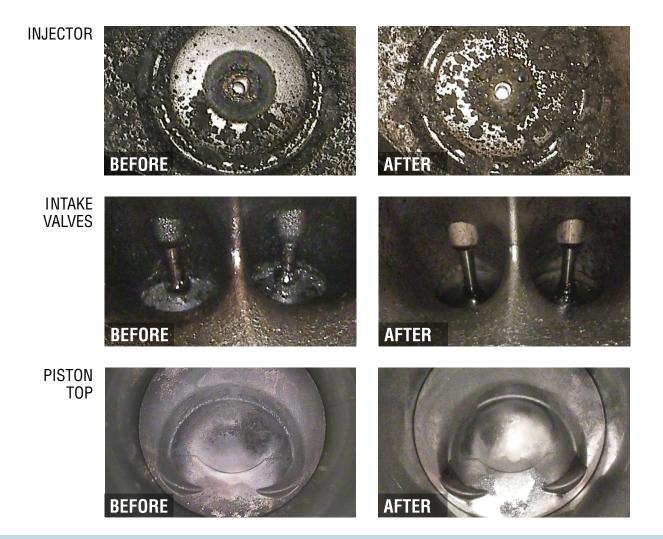
PERFORMANCE TESTING RESULTS

NOTE: The following images on this vehicle were captured after running a full tank of fuel.

Following platform-specific instructions, the BG Platinum[®] Fuel System Service will remove deposits from the backs of intake valves, combustion chambers, and injector tips.
