CASE STUDY: BG PLATINUM® FUEL SYSTEM SERVICE

SERVICE	BG Platinum [®] Fuel System Service	BG PLATINU
PRODUCTS	BG Platinum® Air Intake, Valve & Combustion Chamber Cleaner, PN 26 ⁻ BG Platinum® 44K, PN 208	HALL BG PLATINUM
EQUIPMENT	BG Platinum [®] Fuel Service Supply Tool, PN E101-1249 BG AE03 Intake Adaptor, PN E101-1572	
	VEHICLE: 2014 Mercedes E350, 3.5L 88,124 miles (141,821 km)	Pit i c canol

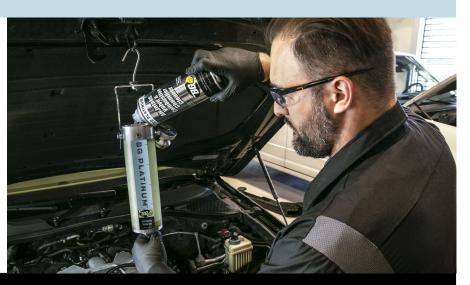
Following platform-specific instructions, the BG Platinum[®] Fuel System Service will remove deposits from the backs of intake valves, combustion chambers, and injector tips.

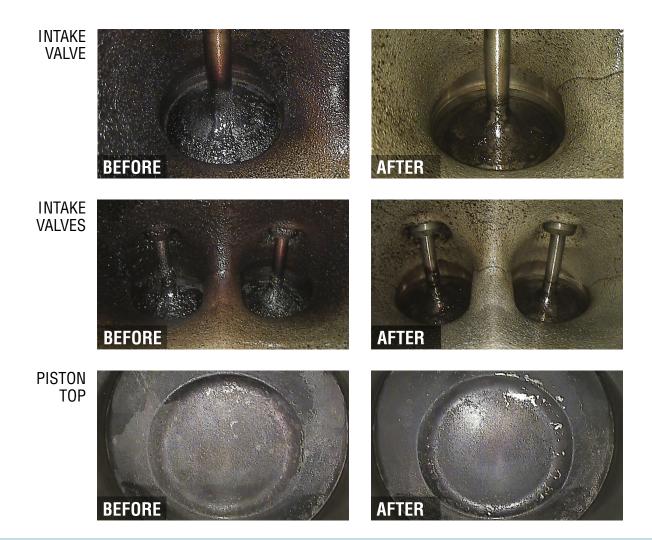
PERFORMANCE TESTING RESULTS

NOTE: The following images on this vehicle were captured after running a full tank of fuel.

- GDI technology offers impressive performance and fuel economy; however, these engines are highly complex and require additional service and preventive maintenance to keep these benefits and prolong the life of the engine, while maximizing fuel economy and vehicle drivability. Frequent carbon cleaning will prevent major issues to the vehicle's engine and fuel system.
- The BG Platinum[®] Fuel System Service uses specialized tools to administer product directly into the intake plenum through an accessible port that draws a metered vacuum. An ultra-fine mist of potent cleaning chemistry is used to thoroughly coat all surfaces removing the maximum amount of deposits in a single service, including heavy deposits from the backs of intake valves, in combustion chambers, and on injector tips.
