</div>	<div>DRAWN</div> <div>DB</div> <div>06/12/2024</div>	<div>STATUS:</div> <div>Work in Progress</div>			
		<div>MATERIAL:</div> <div>See Table</div>		<div>DESCRIPTION:</div> <div>C500 & C500WS CAD BLOCK</div>		
		<div>FINISH:</div>	<div>SIZE</div> <div>A3</div>	<div>DRAWING NO.:</div> <div>90001618</div>		<div>REV.:</div> <div>B</div>
		<div>DO NOT SCALE 3D DATA IS MASTER DIMENSIONING WITH REFERENCE TO BS8888</div>		<div>WEIGHT:</div> <div>g</div>	<div>SCALE:</div> <div>1:10</div>	<div>Sheet 1 of 1</div>
			<div>OUTSIDE DIMS.: H: DB W: DB D: DB</div>

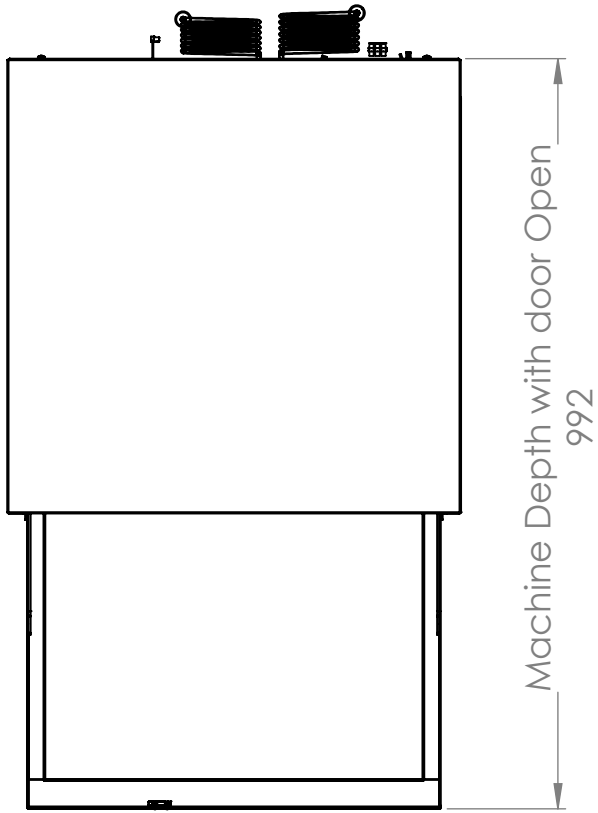
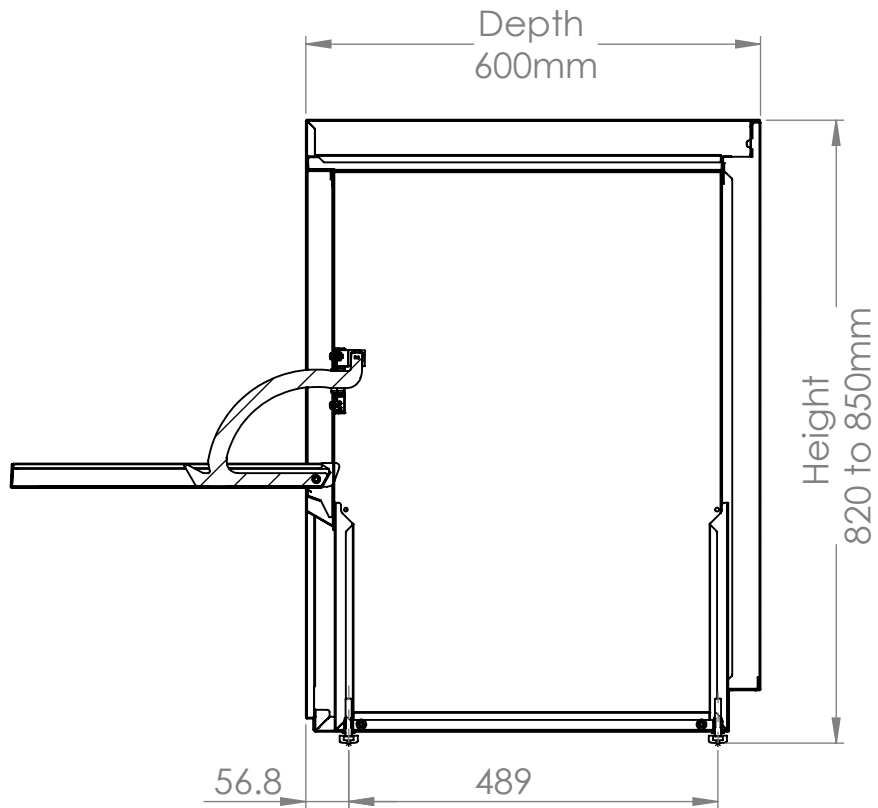
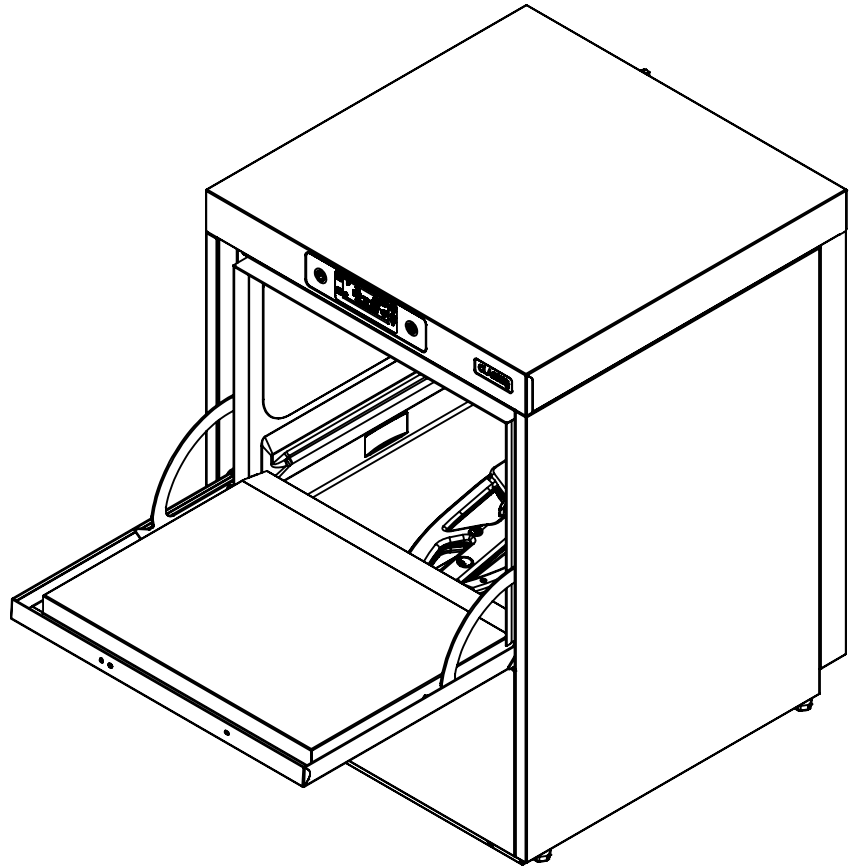
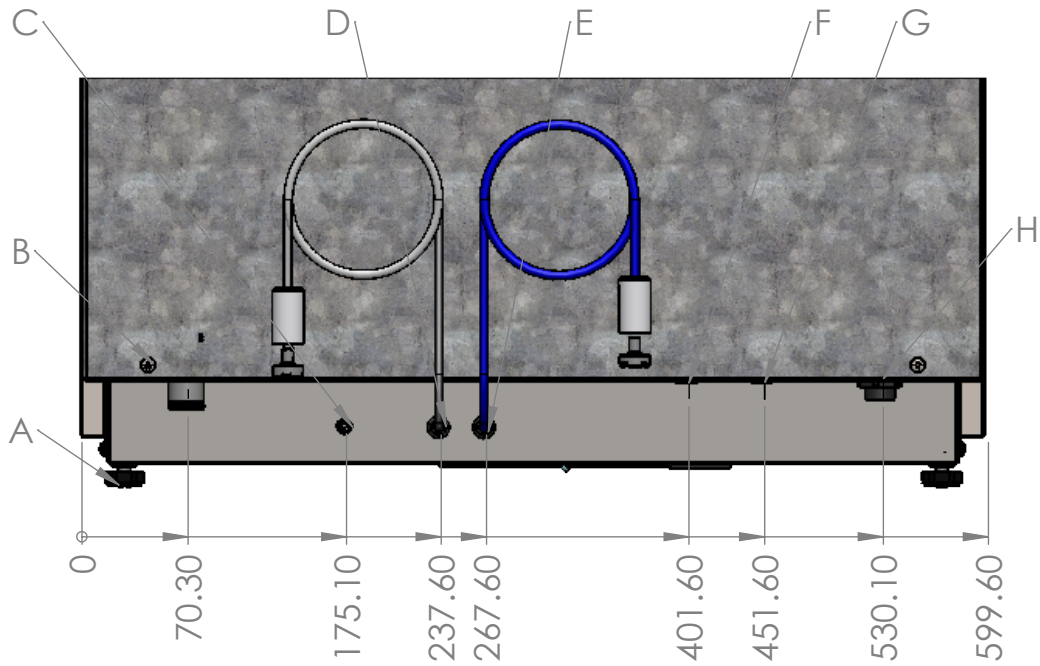
Item	Description
A	Foot (30mm adjustment)
B	Drain Connection
C	Earth point
D	Detergent Tube inlet
E	Rinse Aid Tube Inlet
F	Detergent Lance port
G	Rinse Aid Lance port
H	Main Cable Gland
