Houston, Texas

# Refinery restores wash water pump systems with minimal downtime due to retro-fit pump barrel equipment

Summit ESP® pump replacement parts help repair wash water pump damage after storm with one-week lead time

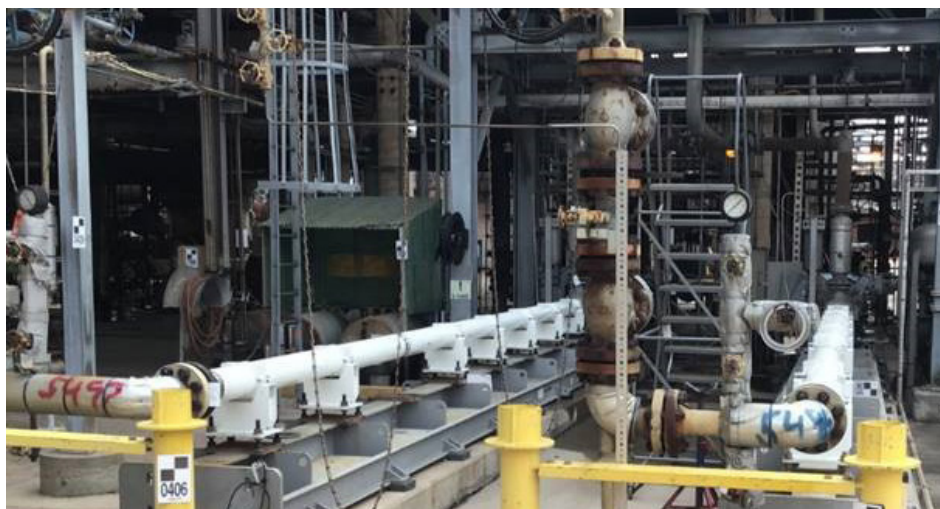
Due to a harsh winter storm that hit Texas, a refinery customer in the Houston area had wash water pump systems that failed due to the cold temperatures. Furthermore, the pump barrels on the main and back-up units had sustained significant damage and needed to be replaced as soon as possible. The legacy wash water pumps were older model competitor surface units, making it hard to source replacement pump barrels, as the original manufacturer discontinued making that component.

The customer reached out to Summit ESP® who was able to match the pump barrel with a slightly higher best efficiency point (BEP) stage, but with similar or overlapping flow, pressure, and the same outside diameter pump housing to fit the customer's existing surface units. The new pump barrel selection had a better head per stage, and as a result, the overall length was shorter, necessitating some adjustment on the existing tandem pump (two pump barrels in series) skid setup. To accommodate this, Summit ESP built a zero-stage pump barrel for each unit to make up the difference in length so that overall pump barrel length exactly matched the previous pumps. This made the installation a direct drop-in replacement operation.
